STONY BROOK DAM

NO. 14

**PHASE 1 INSPECTION REPORT
NATIONAL DAM SAFETY PROGRAM**

STONY BROOK DAM NO. 14 (NJ00154)

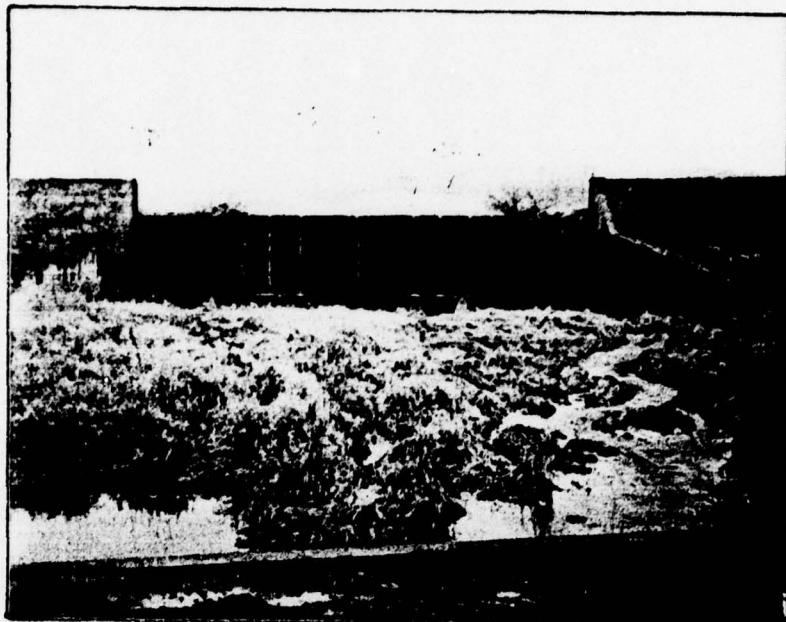
Downstream view of spillway structure

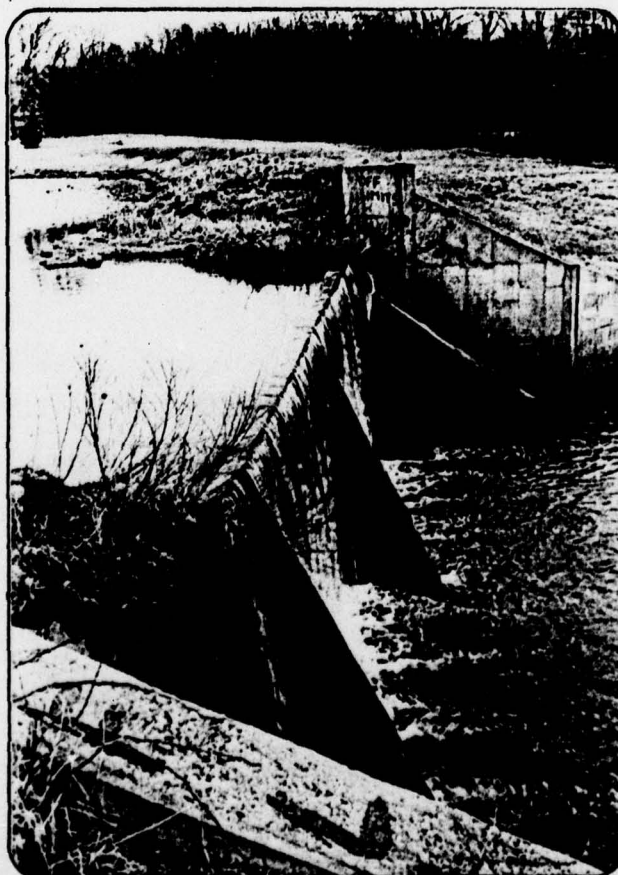
The reinforced concrete spillway appears to be in a satisfactory condition although some superficial spalling was noted on the upper surfaces of the wingwalls. The left and right headwall extensions along the dam axis are slightly offset ($\frac{1}{2}$ inch) in a downstream direction at the vertical construction joints. Also, both wingwalls are offset in a downstream direction about $\frac{3}{4}$ of an inch (relative to the sidewalls). However, no serious structural cracking was noted. The stilling apron is constantly under water and not visible during the inspection. However, the face and crest of the weir as well as the buttresses appeared to be in a satisfactory condition. The gate and stem for the 24" RCP drain is in good condition, but the stem wheel is missing. The plans indicate the pipe originates in the upstream thalweg of the original stream (beyond the upstream toe), passes through the left headwall, makes a 90° turn to the right and exits through the left sidewall. An Armco steel sluice gate is mounted on the wingwall. (See appended plans).

View of spillway structure

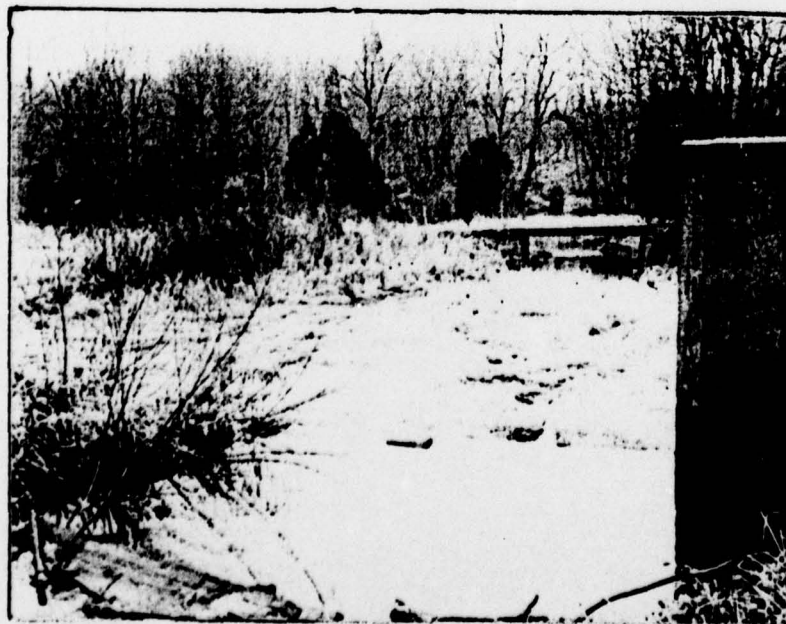
View downstream

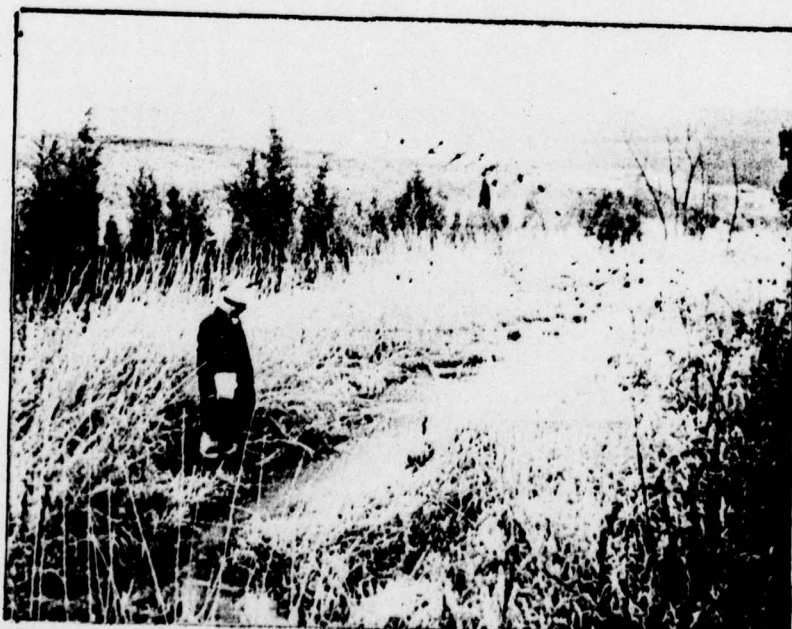
VISUAL EXAMINATION OF	OBSERVATIONS	REMARKS OR RECOMMENDATIONS
Downstream Toe	Small stream parallel to face of dam on right side. Swampy growth along toe indicative of a perennial condition. Growth between stream channel and right embankment.	+ $\frac{1}{2}$ cfs of flow. Water at ground surface over an extensive area.
JUNCTION OF EMBANKMENT AND ABUTMENT, SPILLWAY AND DAM	Grass and bushes growing on sloughed material behind both spillway abutments.	Bushes should be cleared.
ANY NOTICEABLE SEEPAGE	Ground damp along toe of right embankment, however this could be caused by the existence of the stream.	Right embankment built across a stream channel which was diverted along the face of the dam. Old stream bed deposits may be acting as a conduit under the dam. Plans indicate removal.

Stream at toe of dam
